### **Panda**

#### 1810 A 201 MA CLUTCH DRIVEN DISC

Service solution for cases of gearbox noise

**CLUTCH ASSEMBLY**

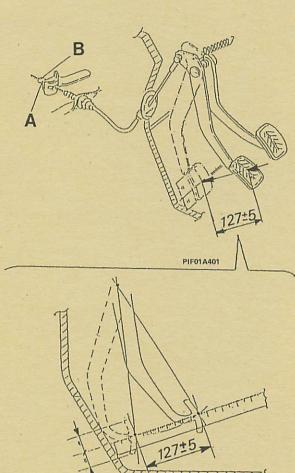
Clutch noisy/difficulties in engaging gears with pedal fully depressed on account of interference between the spring and the driven disc.

- Make sure that there are no obstacles which restrict the total travel of the clutch pedal (remind the Customer to avoid using extra mats under the pedals).
- Let the clutch release bed in by fully depressing the pedal 3 or 4 times.
- Check that the travel of the clutch pedal between the rest position and the end of travel position (see diagram) is equal to 127 ± 5 mm.

A. Nut B. Lock nut

- Working on nut A and lock nut B take care to prevent the rotation of the cable during the adjustment operation.

**NOTE** If after having carried out the operations described above the problem has not been solved, replace the clutch assembly with one ordered from the Parts Division no. 5892499 (supplier Valeo).
