169 - PANDA

SERVICE NEWS > 21 GEARBOX > 21.03.06 GEAR ENGAGEMENT/SELECTION CABLES  
SEIZING, HARDENING - SERVICE SOLUTION[Go back to User's Manual](#)

Fiat Panda (169)

2125 1 261 L F      **GEAR ENGAGEMENT/SELECTION CABLES**  
Seizing, hardening - Service Solution21  
03.06

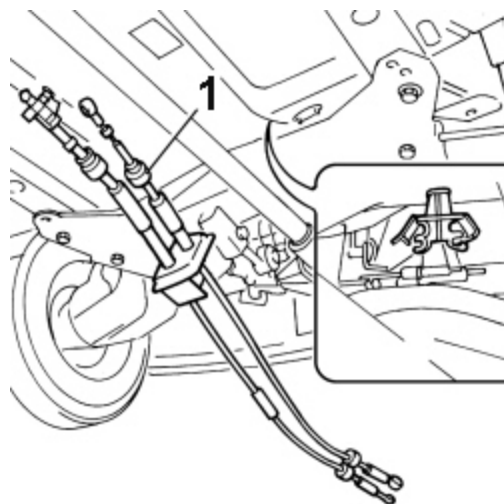
Seizing of the gear engagement cable due to the deterioration of the (PTF) tube inside the outer casing that guides the steel cable.

**C)** Replace the gear engagement/selection cables (1 - Fig. 1) with new ones from the Parts Dept. completing the operations already partly carried out in points A and B (refer to the Service Manual - Op 2125C30).**Fig. 1**
