## Panda All versions

### FUEL VAPOUR RECIRCULATION VALVE

Service solution for cases of noise

# Service News

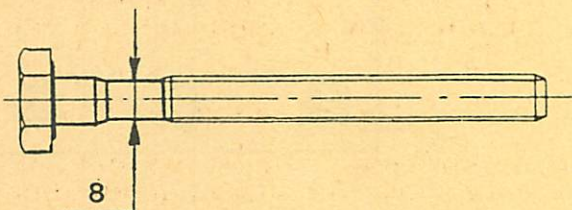
Torque + angle tightening system adopted and  
cylinder head gasket with relevant screws  
consequently replaced.

### ANTE-MODIFICATION SOLUTION (up to eng.no.8 581 458)

- Screws as per figure A
- Cylinder head gasket with silicone added on one side only
- Screws torque tightened to 6 daNm

POST-MODIFICATION SOLUTION (from eng.no.8 581 459)

- Screws as per figure B
- Cylinder head gasket with silicone added on both sides
- Screws torque + angle tightened to 3 daNm + 90°+90°.

NOTE On P.M. engines re-tightening of the screws  
==== is no longer required on "Free Service  
Coupon" or after 1000...1500 km from the  
first re-tightening on service, if performed.

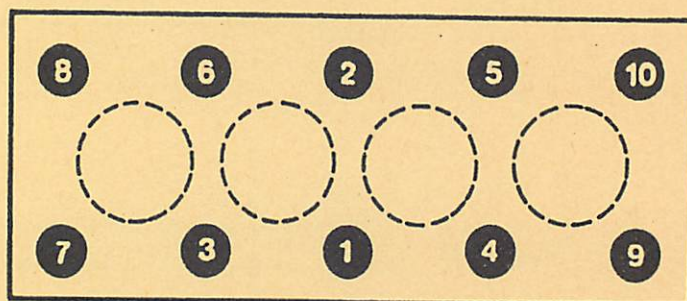
Cylinder head screws are to be tightened according  
to the sequence shown in the figure.

- 1) Lubricate screws and washers with VS 30 oil and let them drip 30 minutes at least.
- 2) Tighten the screws to 2 daNm
- 3) Torque tighten to 3 daNm

- 4) Additionally tighten the screws with a standard wrench by a 180° angular rotation in two distinct steps (90°+90°) according to the sequence prescribed.

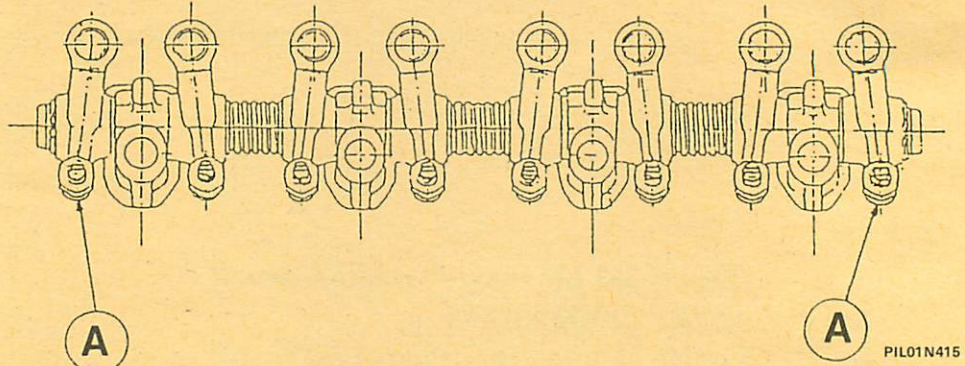
FIGURE 1

Noisy tappets caused by the hardening of the rocker arm shaft.

A) Rocker arms 1-8

- Remove the rocker arm shaft.
- Remove rocker arms 1-8 from the shaft (A in figure 1).
- Replace the two thrust washers shown in figure 2 with different ones ordered from the Parts Division by quoting no. 46419826.
- Refit the rocker arms.
- Fill the tappets with oil as described in the Service Manual.
- Refit the rocker arm shaft.

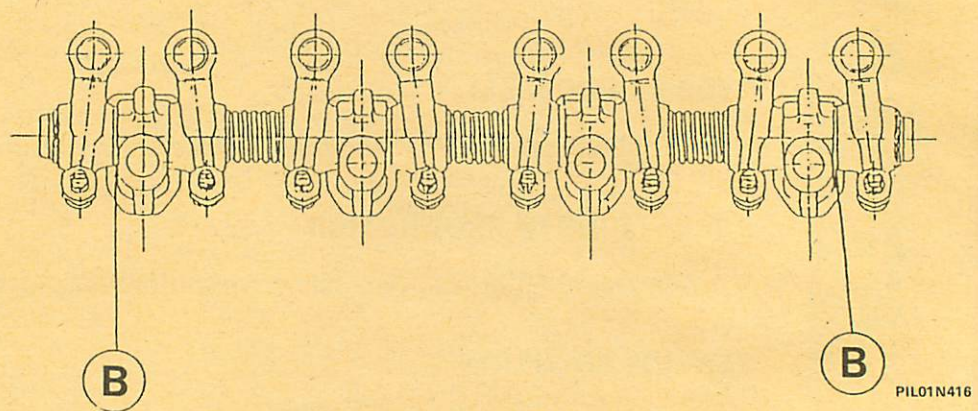
FIGURE 2

B) Washers to replace

Replacing the 1.5 mm washer with another one 1.2 mm thick no. 46419826.

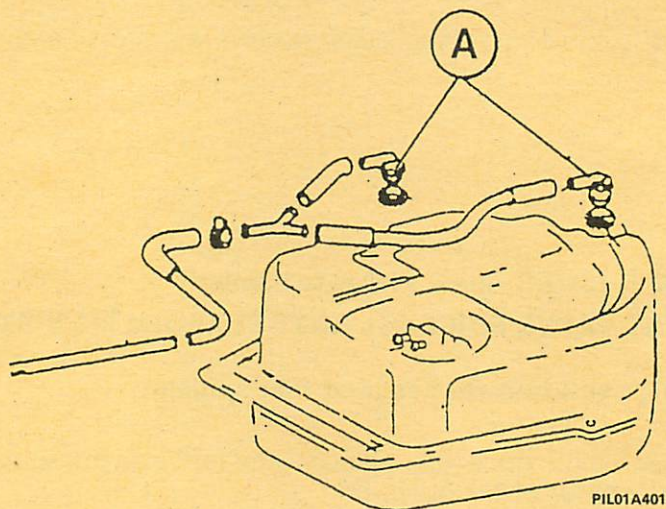
Petrol escaping.

A) Float valve

Replacing the float valve with a modified one supplied by the Parts Division no. 7689120 which although it is the post-modification type can be either white or grey.

- Remove the petrol tank.
- Replace the two float valves with new ones ordered from the Parts Division no. 7689120.
- Refit the tank.

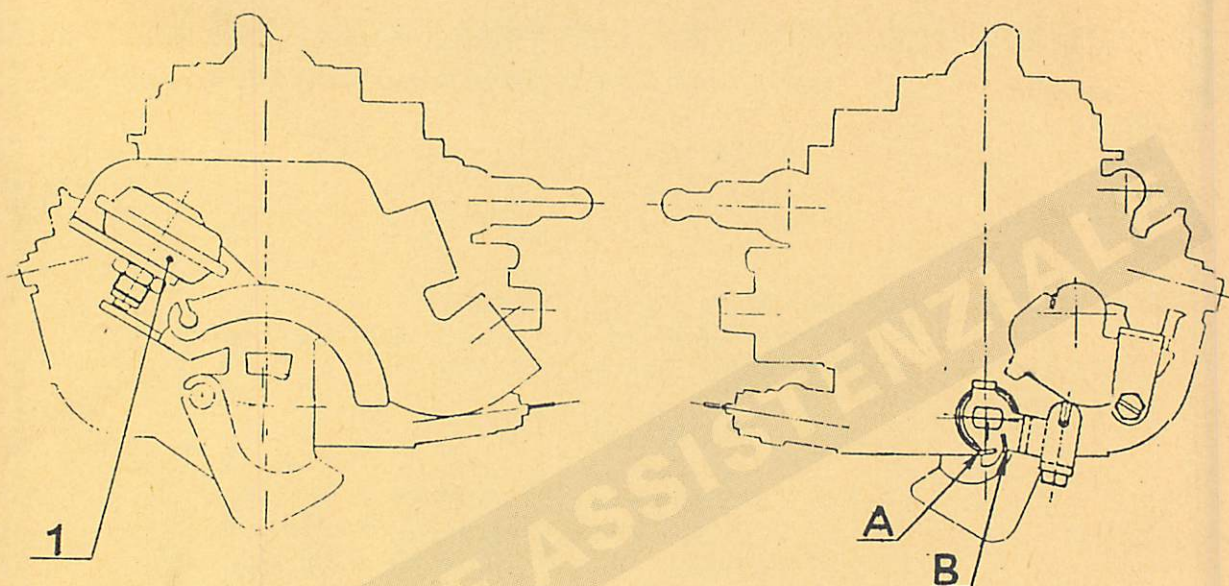
In case of excessive accelerator load which could occur on the first units produced since they are equipped with accelerator return spring calibrated at higher load and "Dash-Pot" device (1 " in figure) proceed as follows:

1 = "Dash-pot" device (to be suppressed)

A = spring position with higher load

B = spring position with lower load (to be obtained by service solution)

- remove "Dash-Pot" device (1 in figure) by slackening the screws securing it to carburettor
- acting with a screwdriver on throttle valve axis move return spring hooking from "A" to "B" position shown in the figure so that spring load is reduced.
