169 - PANDA

SERVICE NEWS > 10 ENGINE > 10.33.10 OIL VAPOUR RECIRCULATION PIPE  
ENGINE OIL VAPOUR RECOVERY PIPE (BLOW-BY) DETERIORATION - SERVICE SOLUTION

All 1.2 8v and 1.4 8v models, excluding LPG and methane versions - Idea, 500, Panda, Grande Punto, Punto Evo, Linea, Doblò (119 / 223)

**1080 1 581 BC**      **OIL VAPOUR RECIRCULATION PIPE**  
**Engine oil vapour recovery pipe (blow-by) deterioration - Service Solution**

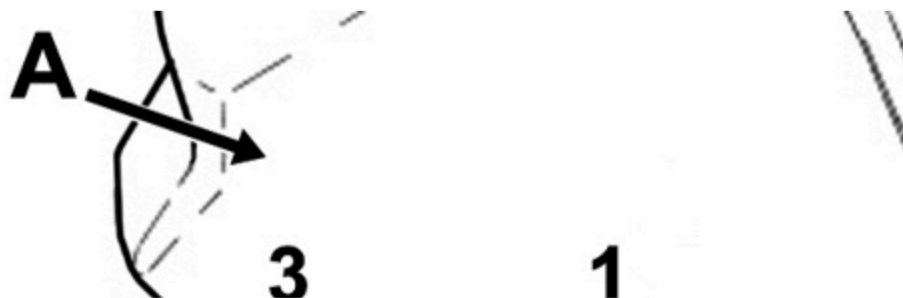
Fig. 1

-Remove the air filter with cold air intake (A - Fig. 1) operating as described in Op. 1048A10 of the Service Manual;-Loosen the retaining bands (1) and remove the oil vapour recirculation pipe (2) operating as described in Op. 1080D22 or 1080D24 of the Service Manual.-Loosen the fixing band and disconnect the engine oil vapour recovery pipe (3) at idling speed.

Once the customer's claimed fault is confirmed, replace the engine oil vapour recovery main pipe (blow-by), then check the engine oil vapour recovery pipe at idling speed and, if damaged, replace it according to the Operating Cycle below.
