NUOVA BRAVO 1.4 16v GAS DISCHARGE DIPPED/MAIN BEAM HEADLAMP BULB - R.R. 5540B45

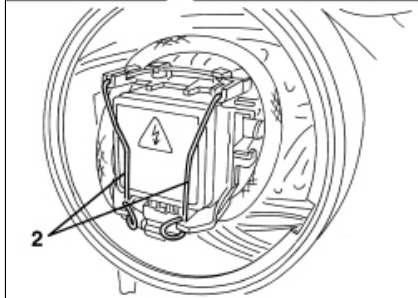
- Open the bonnet.
- For the left headlamp only.

Op. 5050A12 WINDSCREEN WASHER FLUID RESERVOIR FILLER PIPE (IN ENGINE COMPARTMENT) - R.R.

- For the left headlamp only.

Op. 7210A03 R.R. BRACKET CONNECTING FRONT END TO SIDE PANEL/STRUT

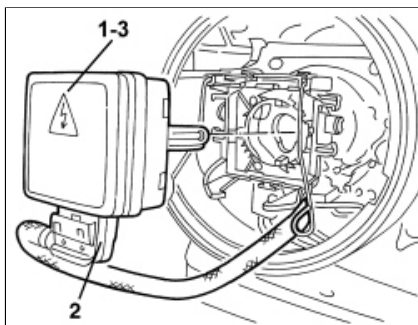
1. Remove the rubber cover.
2. Release the bulb retaining clips.

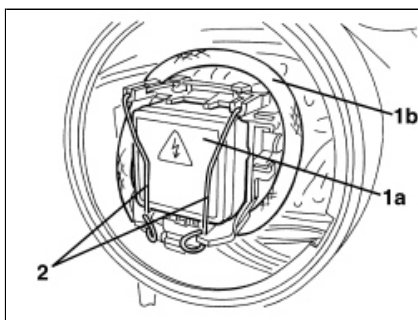
1. Extract the bulb from the bulb holder.

2. Disconnect the electrical connection for the bulb.
3. Keep the bulb.
