## Panda All versions

### FUEL VAPOUR RECIRCULATION VALVE

Service solution for cases of noise

# Service News

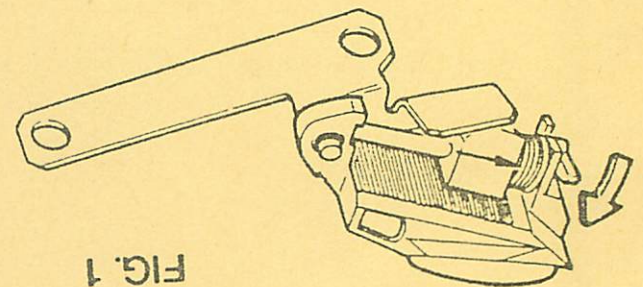
FIG. 1

- After having replaced chain and gears and before fitting the cover, fit the shoe part no. 7661126 with bracket no. 7711828, fixing it by ring part no. 11087776. All the above parts are available as spare.
- Fit shoe-bracket assembly under support no. 1 of crankshaft (see fig. 2)
- Tighten support bolts at 6.9 daNm
- Rotate plastic lever of 60...90 degrees alternatively, in order to disengage tensioning spring of the shoe (see fig. 3)
- Fit the new cover part no. 7663711
