NUOVA BRAVO 1.4 16v TAILGATE LOWER INTERIOR PANEL-R R 7015A05

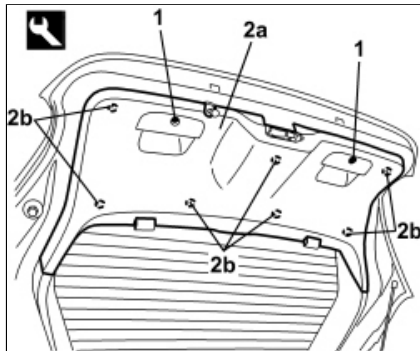
1. Undo the bolts.

2. Remove the lower inner panel (2a) releasing the inner retainers (2b) using the special tool.

- Check that the lower inner panel is not damaged.

- Position the panel and engage the inner retainers.

- Tighten the bolts.
